**Docket No. 217 – Development and Management Plan Inspection**

Northeast Utilities Service Company Certificate of Environmental Compatibility and Public Need for the construction of a 345-kV electric transmission line and reconstruction of an existing 115-kV electric transmission line between Connecticut Light and Power Company's Plumtree Substation in Bethel, through the towns of Redding, Weston, and Wilton, and to the Norwalk Substation in Norwalk, Connecticut.

**Date:** August 10, 2005

**Location:** Transition Stations (Hoyts Hill, Archers Lane)

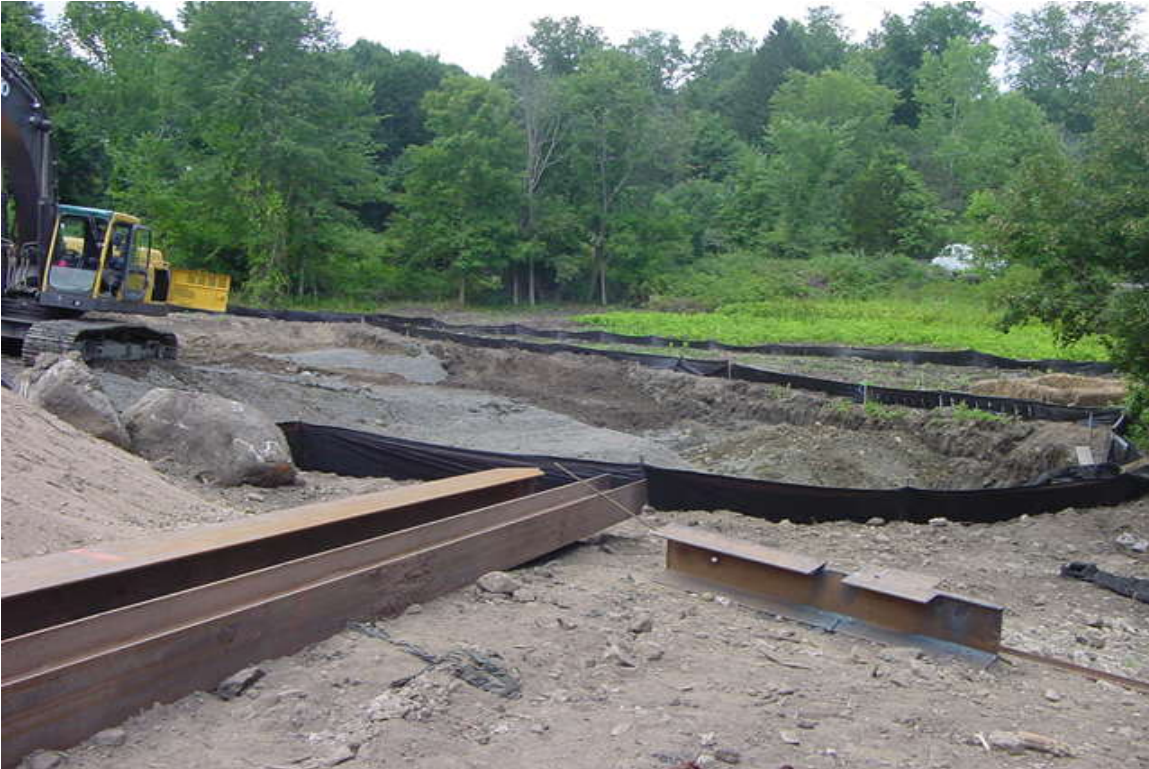
Hoyts Hill Transition Station: Overall view of the earthwork occurring at the site and the excavation for foundations. (8/10/05)

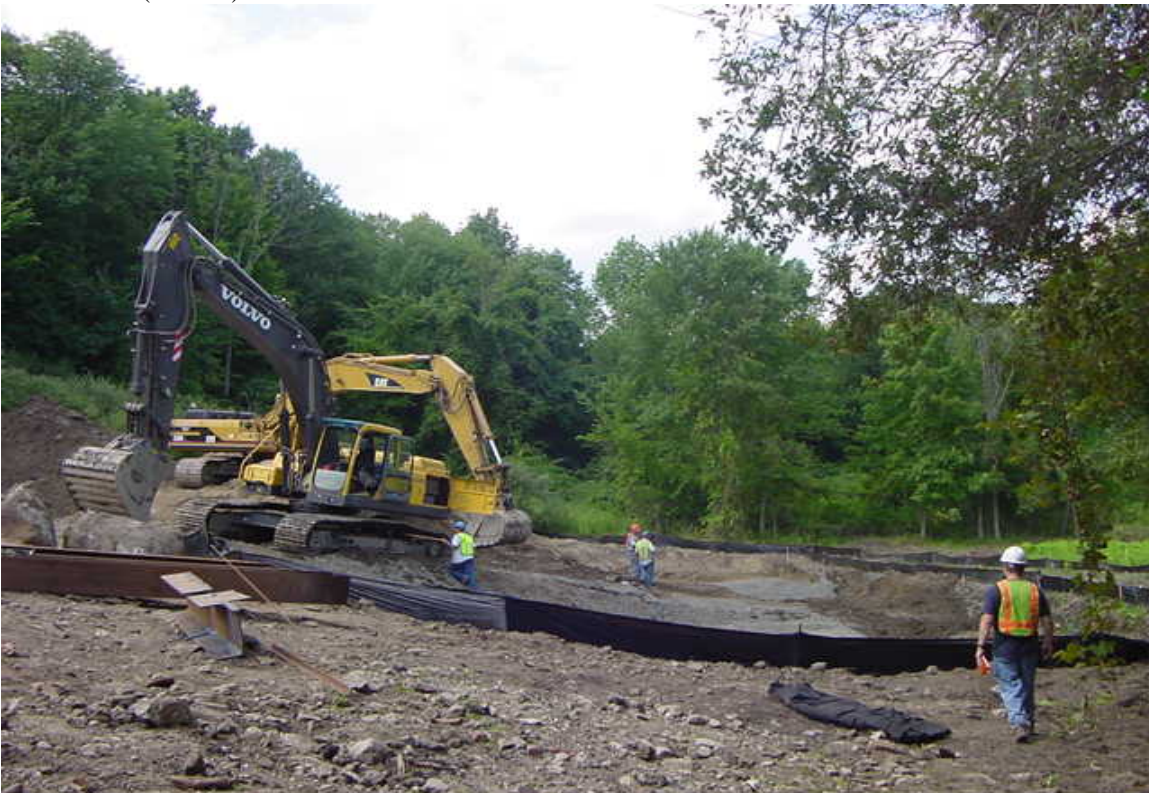
Additional view of site work. All silt fence is in good condition. (8/10/05)

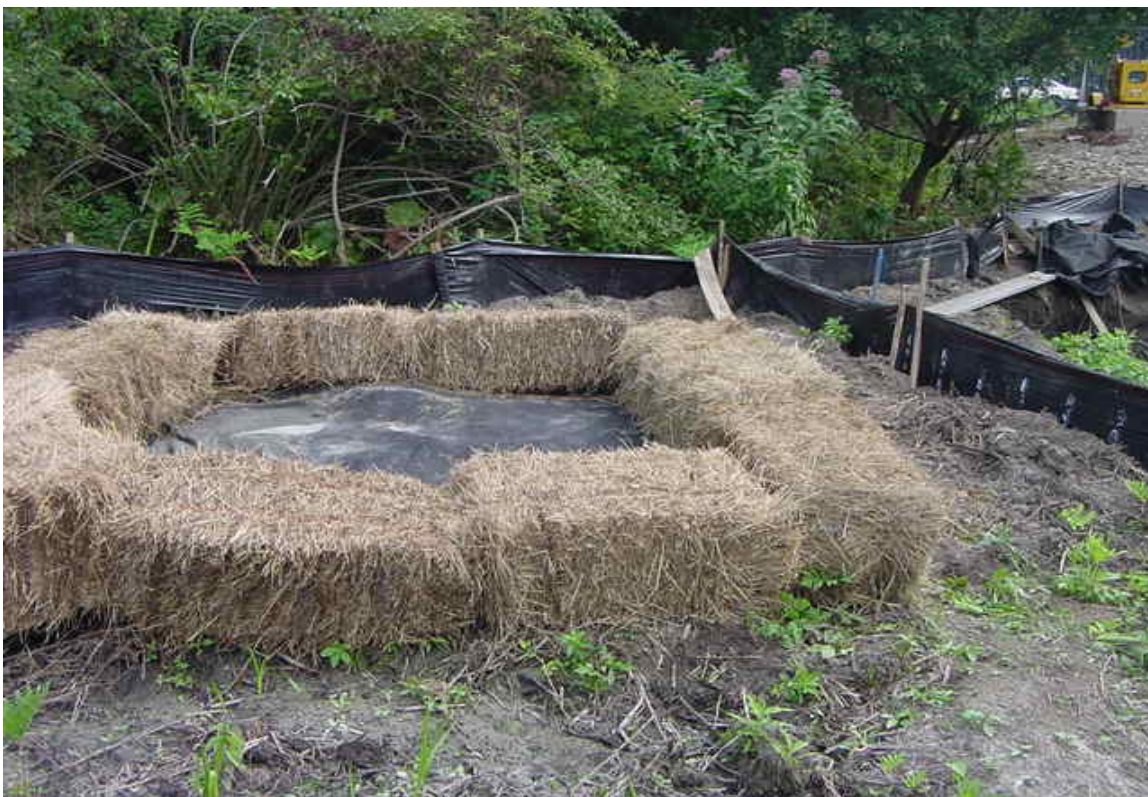
View of the filter bag and corral for dewatering the excavations. (8/10/05)

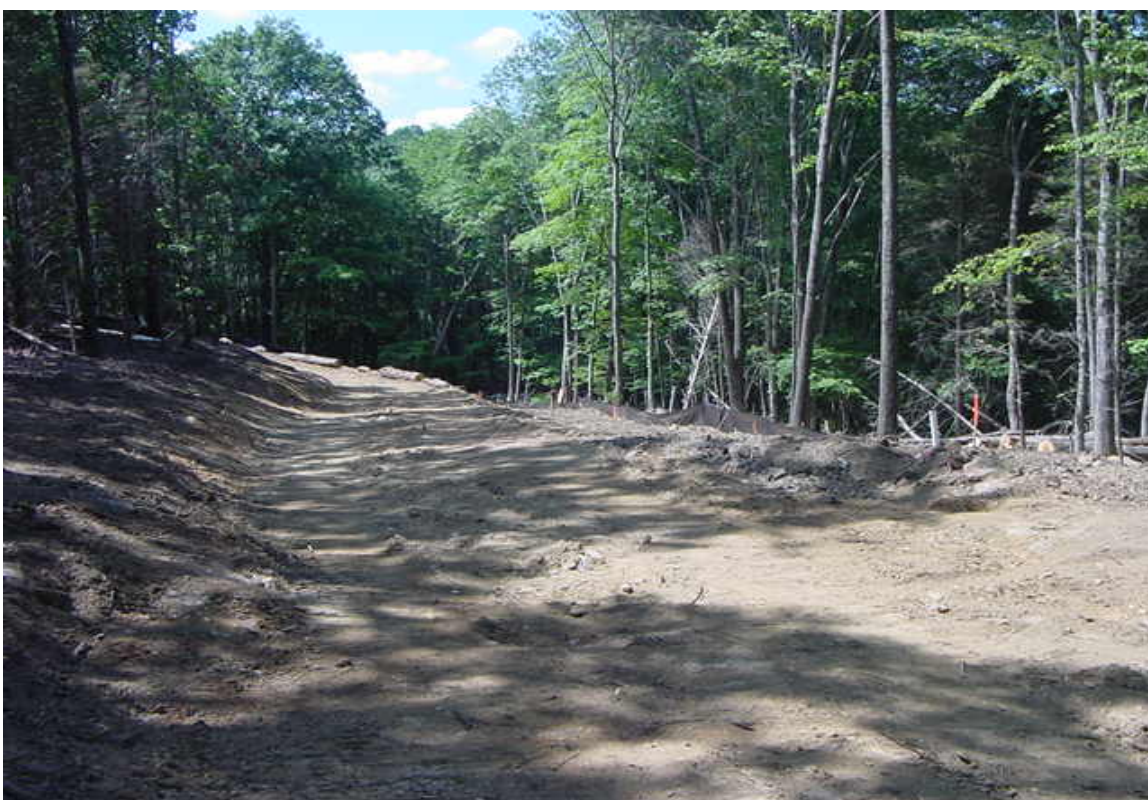
Archers Lane Transition Station: View of the cleared access into the site. No additional work was ongoing at the time. (8/10/05)
